**SEISMIC EVALUATION OF I24 BRIDGES
AND EMBANKMENTS IN WESTERN KENTUCKY
SUMMARY REPORT**

Research Report
KTC-06-20/SPR206-99-1F

SEISMIC EVALUATION OF I-24 BRIDGES AND EMBANKMENTS IN WESTERN KENTUCKY - SUMMARY REPORT

September 2006

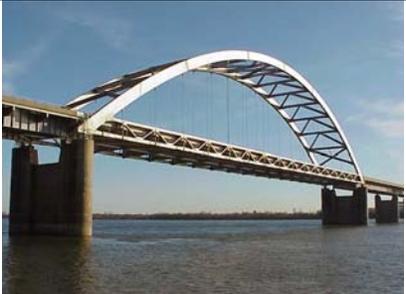
Do you think abutment-slope failures are possible in an earthquake?					Yes <input type="checkbox"/> No <input type="checkbox"/>	
OTHER	¹ Corrosion of the steel plates connected to the abutments is noticeable.

Fig. 3 Inspection of Bridge # 73-0024-B00100 and Bridge # 73-0024-B00100P on I-24

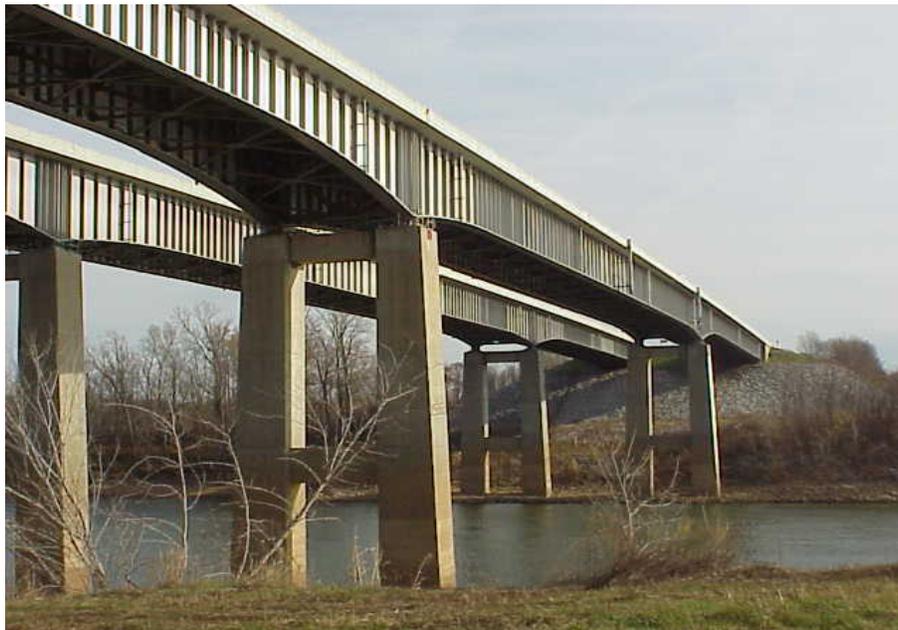
The seismic analysis indicated that the main spans of the bridge can resist the 250-year event without yielding or loss-of-span at the supports. Consequently, retrofitting is not required for the main bridge members and bearings for the 250-year event (Fig. 11).

**Fig. 11 Capacity of members and bearings of the main spans of the Cumberland River Bridges exceeds demand for projected 250-Year Seismic Event.
[Consequently no retrofit is required]**
